# Restoration of Viking Valiant, Hammarlund SP-600 and Heathkit HX-10 Marauder

Phase 1 - Johnson Viking Valiant Transmitter

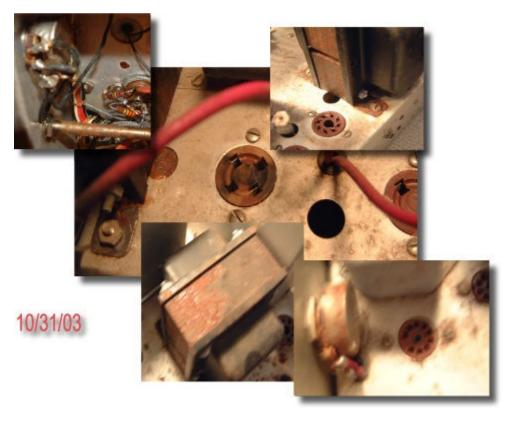
Chassis corrosion most likely resulting form moisture accumulation over the years. Note the evidence of arching of the one of the 866 Mercury Vapor H.V. Rectifier tube sockets in the center of this photo montage.

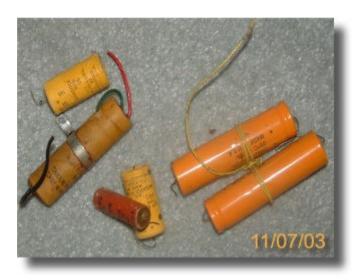
Several old electrolytic capacitors removed from the Valiant

List of electrolytic capacitors (orange arrows) that were replaced. The .5 mfd paper capacitor looked suspect and was also replaced. The four .1 paper capacitors looked good and were left intact (for now).

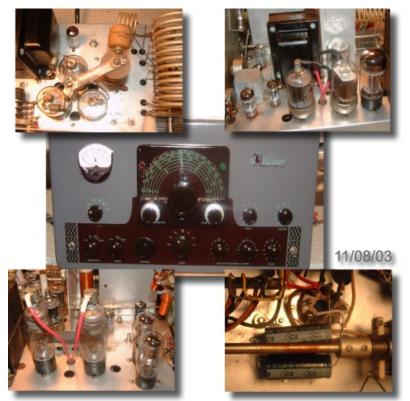
A montage of photographs taken after the Valiant was reassembled following completion of phases 1 and 2.

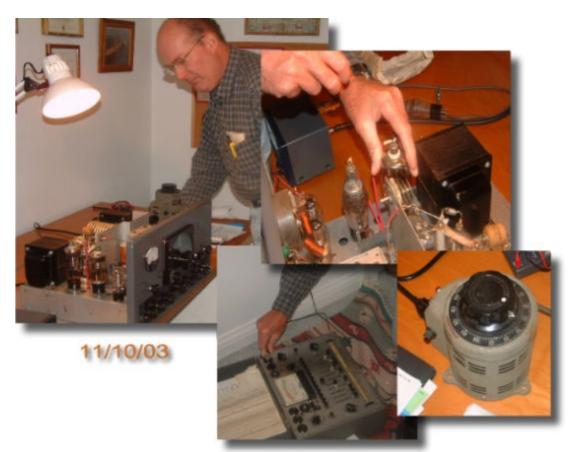
Bill "KJ4W" giving the Valiant the initial "smoke test". Fortunately we didn't get any smoke but not much power either... only about 20 watts but perhaps to be expected since the old girl hadn't been on line since the 80s! Note in this photo montage that a **variac was used to slowly bring up voltages** to the rig following completion of tube testing. Also note (in the top right photo) the replacement of two original 866 mercury vapor tube rectifiers with **two 3B28 tubes** provided by Bill "KJ4W".

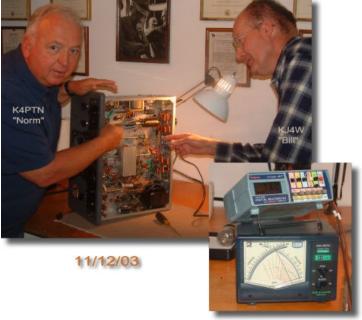
Norm "K4PTN" (who drove up from nearby Paris Landing) and Bill "KJ4W" running the Valiant through more tests. This time we were pleased to be able to achieve 150 watts output as noted on the watt meter.

- Panel meter inoperative. Bill "KJ4W' found a good internal meter movement which was retrofitted to the meter housing.
- One faulty 6146 modulator tube. Both tubes were replaced with a **matched pair of 6146B** tubes provided by Norm "K4PTN".

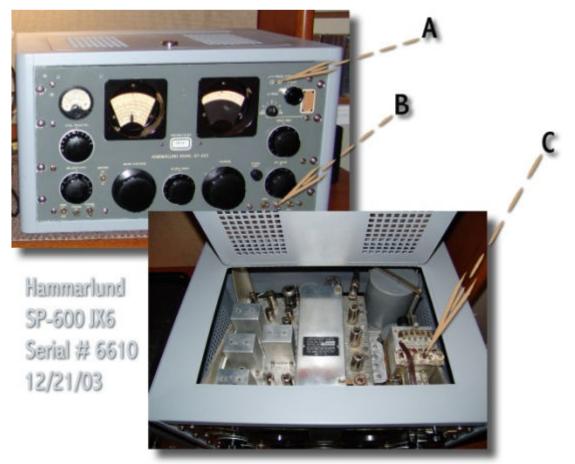
Above are photographs of the restored SP-600 receiver. Note the presence of 3 previously made modifications:

- A External crystal socket for plug-in of an additional crystal for fixed-frequency reception at high stability.
- **B** Switch to select crystal-controlled BFO for improved SSB detection.
- C Trimmer capacitors for fine-tuning fixed-frequency reception crystals.

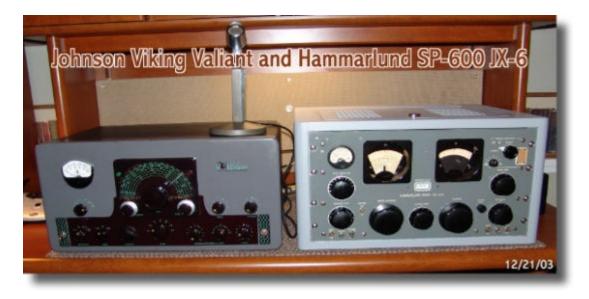
Restoration completed! The first contact on the Valiant/Hammarland SP-600 combo was made 12/15/03 on 3880 AM with WB9ECK "Bob" near Madison, Wisconsin. Bob gave KG9OM "Don" a S9 +20db report and indicated that the audio sounded fine. Received audio was excellent.

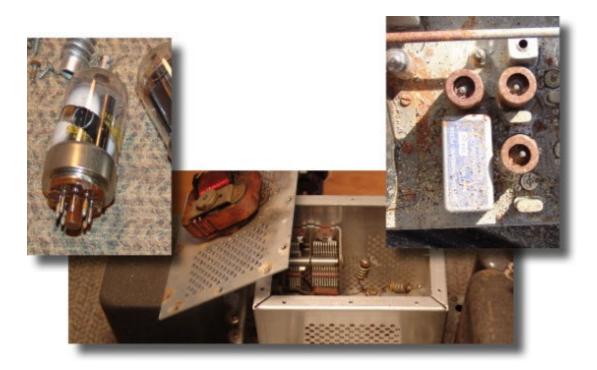
Chassis corrosion and debris accumulation over the years. Note the cracked 6146B power amplifier tube in the left of this photo montage.

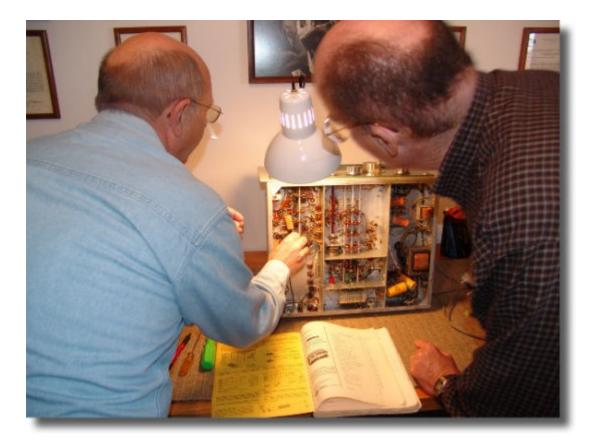
K4ENE "Don" and KJ4W "Bill" inspect the components beneath transmitter's chassis. All tubes (lower center photo in the montage) were tested with seven (including both 6146 power amp tubes) requiring replacement.

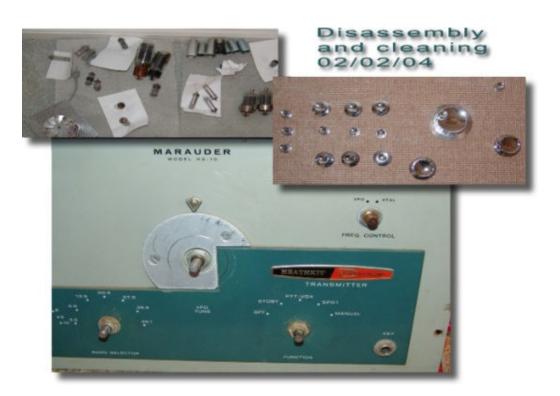
Tubes and knobs have been cleaned and ready for reassembly. Front panel paint is in good shape and will only be cleaned.

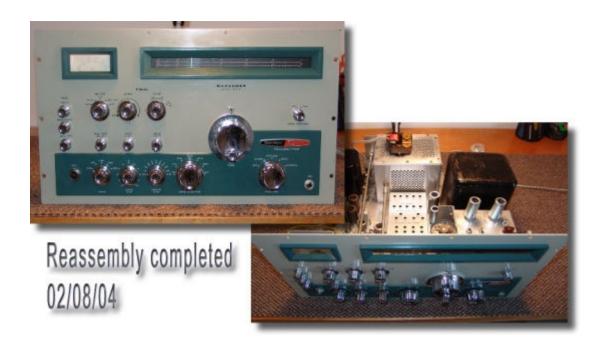
#### Step 4 - Operational testing:

The Marauder was slowly powered up with a variac 02/27/02. Low and high voltage checks were within limits. However, the vfo required complete re-alignment which was expected since the linkage had been disassembled and cleaned during step 2.

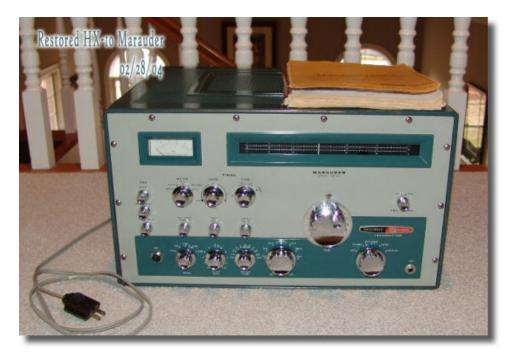
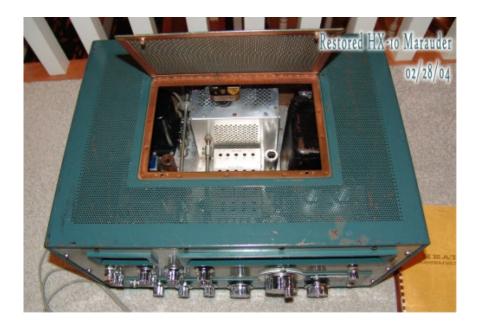
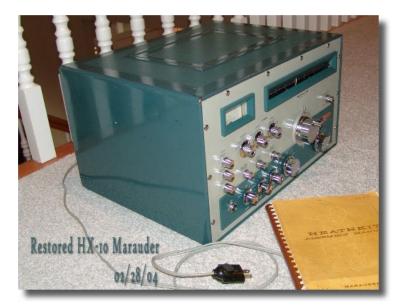
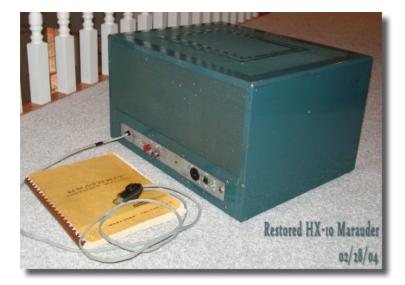
Here are several photographs of the restored Marauder: (note original manual)
